NASA-CR-174537

## FLIGHT-SERVICE PROGRAM FOR ADVANCED COMPOSITE RUDDERS ON TRANSPORT AIRCRAFT

Third Annual Summary Report  
Covering airline service between  
1 June 1978 and 30 June 1979

McDonnell Douglas Corporation

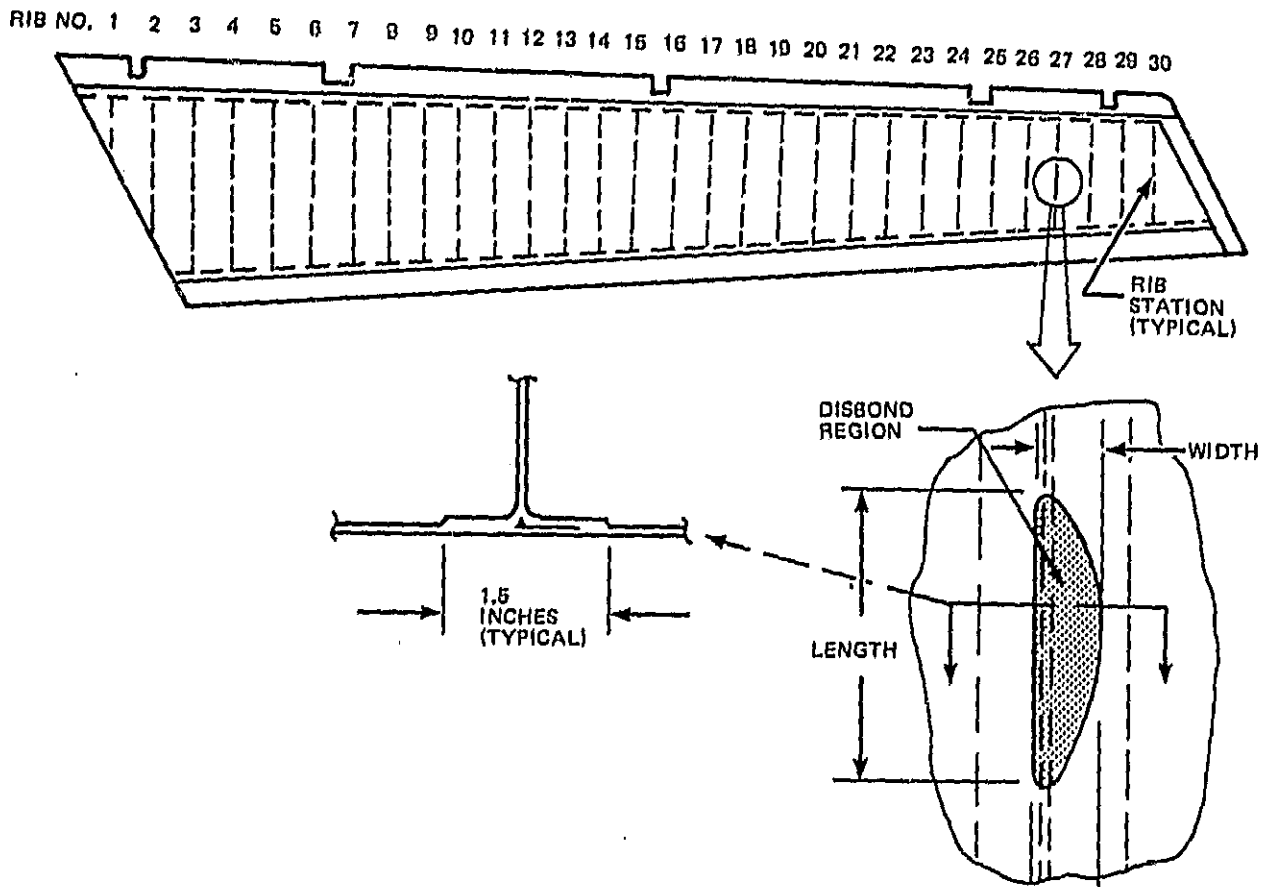
FIGURE 1. DEFECT DETECTION ON AIR NEW ZEALAND COMPOSITE RUDDERS'

Non-destructive inspections were also conducted by ANZ personnel on aircraft fuselage numbers 69 and 116 during the reporting period. The ANZ inspectors had previously reported three localized bondline anomalies at the rib to skin panel interfaces of the former aircraft (see Reference 1). These anomalies were later confirmed by Douglas engineers. One similar anomaly was also detected on the latter aircraft.

The bondline anomalies were first believed to be local thickness variations at the rib flange to skin panel interfaces. The anomalies are presently believed to be interlaminar resin cracks or disbonds which originated in the fillet regions at the centers of the rib flange to skin panel interfaces, probably during cooldown after the manufacturing cure cycle. The suspected disbonds were not detected during the original non-destructive inspections of the rudders and were first detected in May 1977 after 2948 hours of flight-service on fuselage number 69.

Three of four suspected cracked regions are stable with no growth reported during subsequent inspections. One region has indicated some propagation of cracking as shown in Figure 1. The disbonds do not impair the strength or function of the rudders so flight-service is continuing. These regions will be observed for further indications of damage propagation as the flight-service progresses.

Some paint chipping and cracking was also observed on the composite rudder of aircraft fuselage number 96 during the 6 May 1979 inspection. The paint chipping occurred in the vicinity of the center hinge bracket (near ribs 15 and 16 on Figure 1) on the right-hand side of the fiberglass leading edge segment. The paint on the graphite composite box-section was not affected. The defect was repaired using standard cleaning and painting techniques for fiberglass components.

AIRCRAFT FUSELAGE NO.	DEFECT LOCATION	INSPECTION DATE	FLIGHT HOURS	LENGTH INCHES	WIDTH INCHES	REMARKS
69	RIB 7 RH SIDE UPPER FLANGE	5/3/77	2,948	3.00	0.25	DISBOND DETECTED
		5/25/78	7,519	3.00	0.25	NO CHANGE
		11/7/78	9,465	0	0	NO DISBOND DETECTED
		1/9/79	10,200	0	0	NO DISBOND DETECTED
	RIB 8 LH SIDE UPPER FLANGE	5/3/77	2,948	1.25	0.25	DISBOND DETECTED
		5/25/78	7,519	1.25	0.25	NO CHANGE
		11/7/78	9,465	1.25	0.25	NO CHANGE
		1/9/79	10,200	1.25	0.25	NO CHANGE
	RIB 27 LH SIDE UPPER FLANGE	5/3/77	2,948	1.25	0.25	DISBOND DETECTED
		5/25/78	7,519	1.25	0.25	NO CHANGE
		11/7/78	9,465	2.00	0.62	GROWTH INDICATED
		1/9/79	10,200	2.25	0.62	SMALL GROWTH INDICATED
116	RIB 20 LH SIDE LOWER FLANGE	3/17/78	2,800	0	0	NO DEFECTS
		5/25/78	3,563	0	0	NO DEFECTS
		11/1/78	5,512	0.75	0.25	DISBOND DETECTED

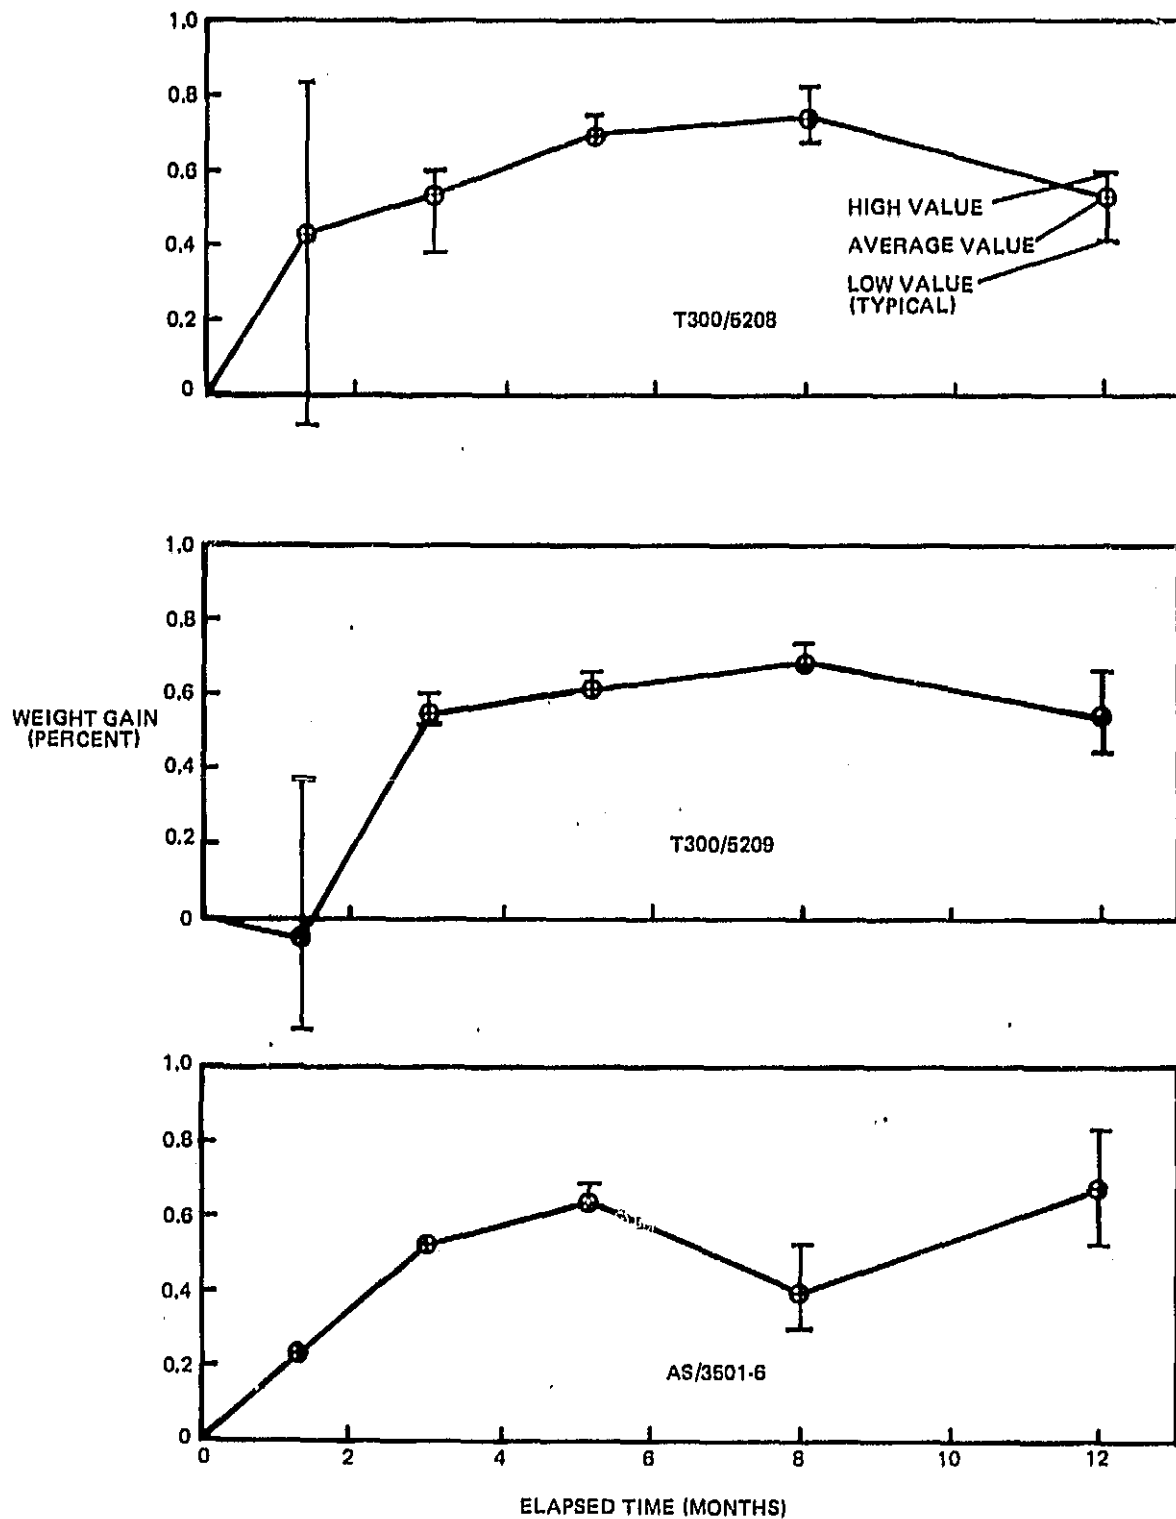
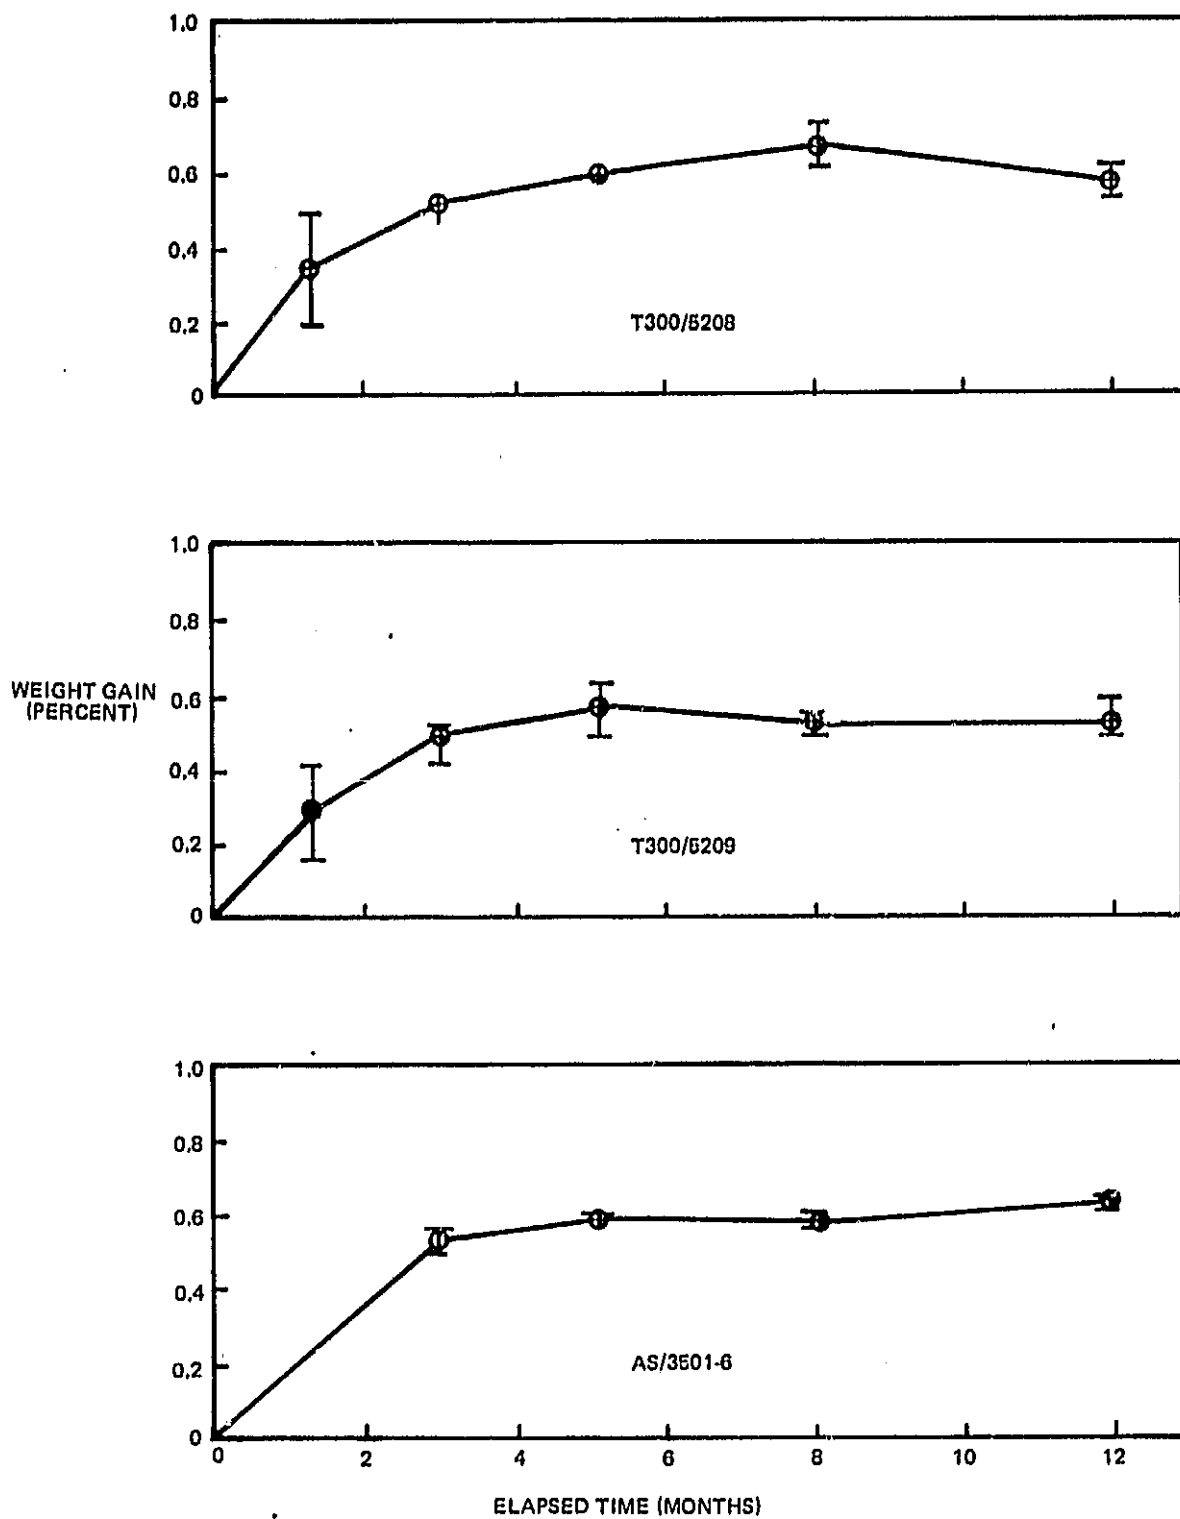
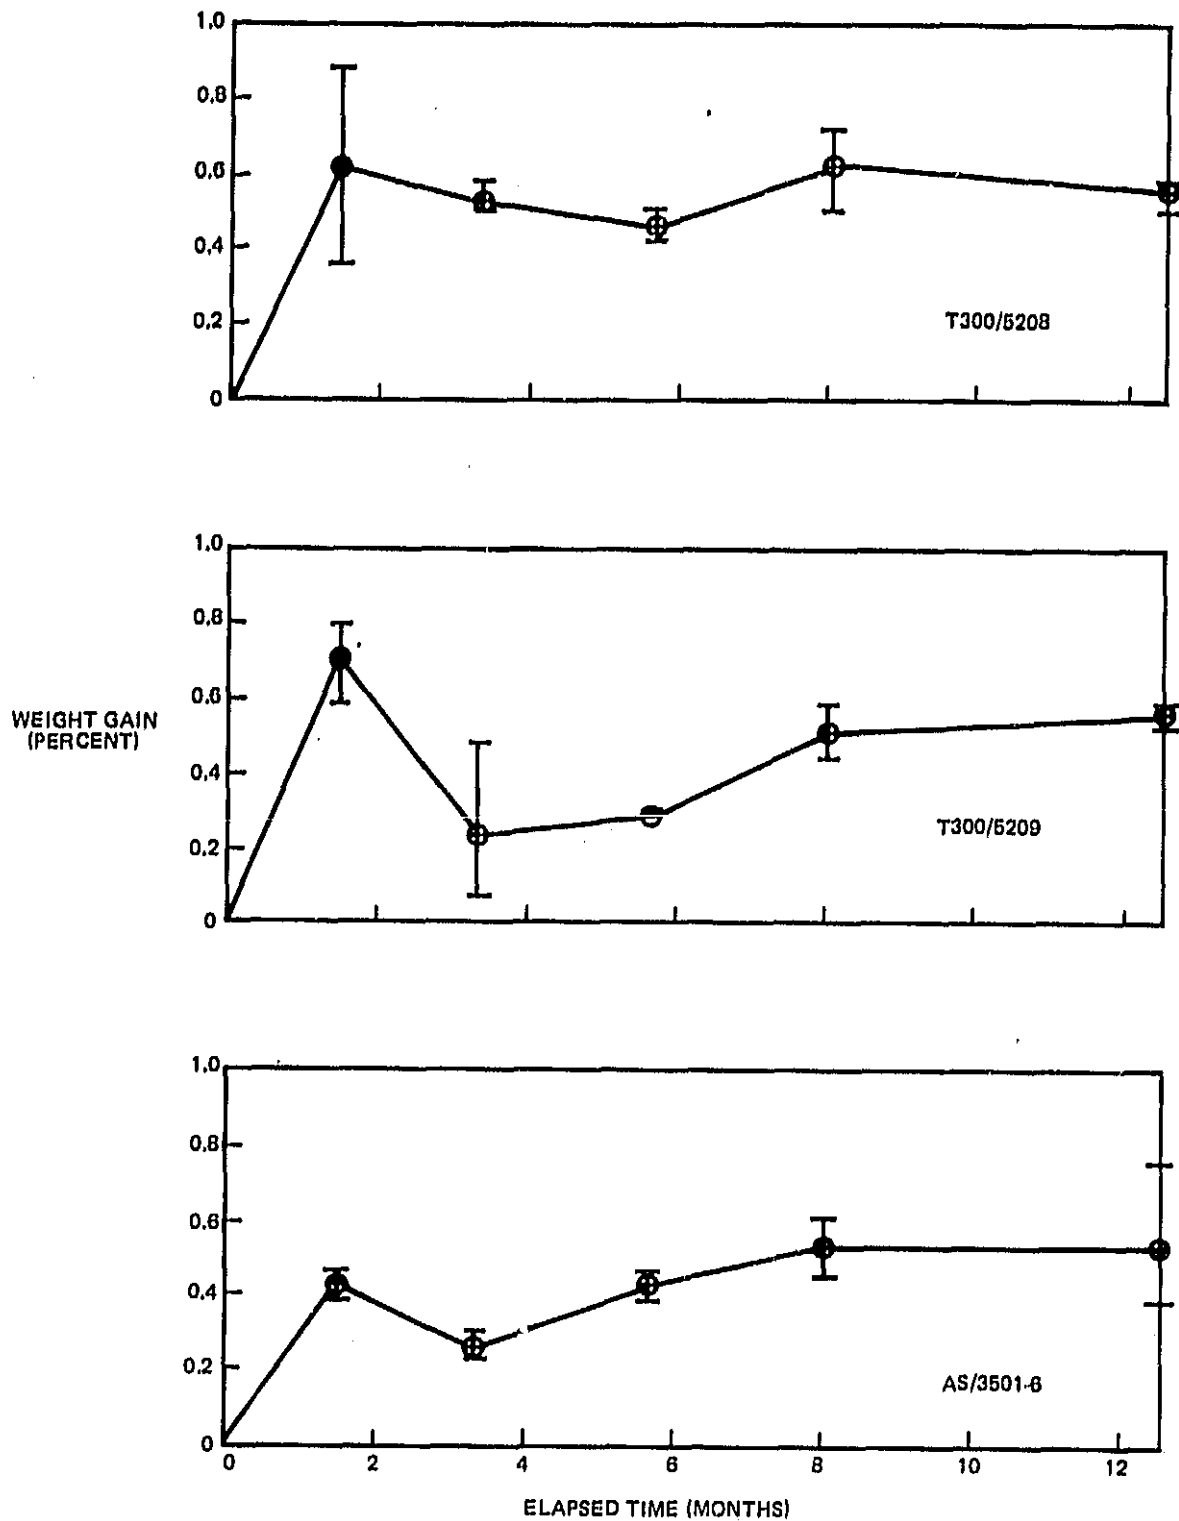
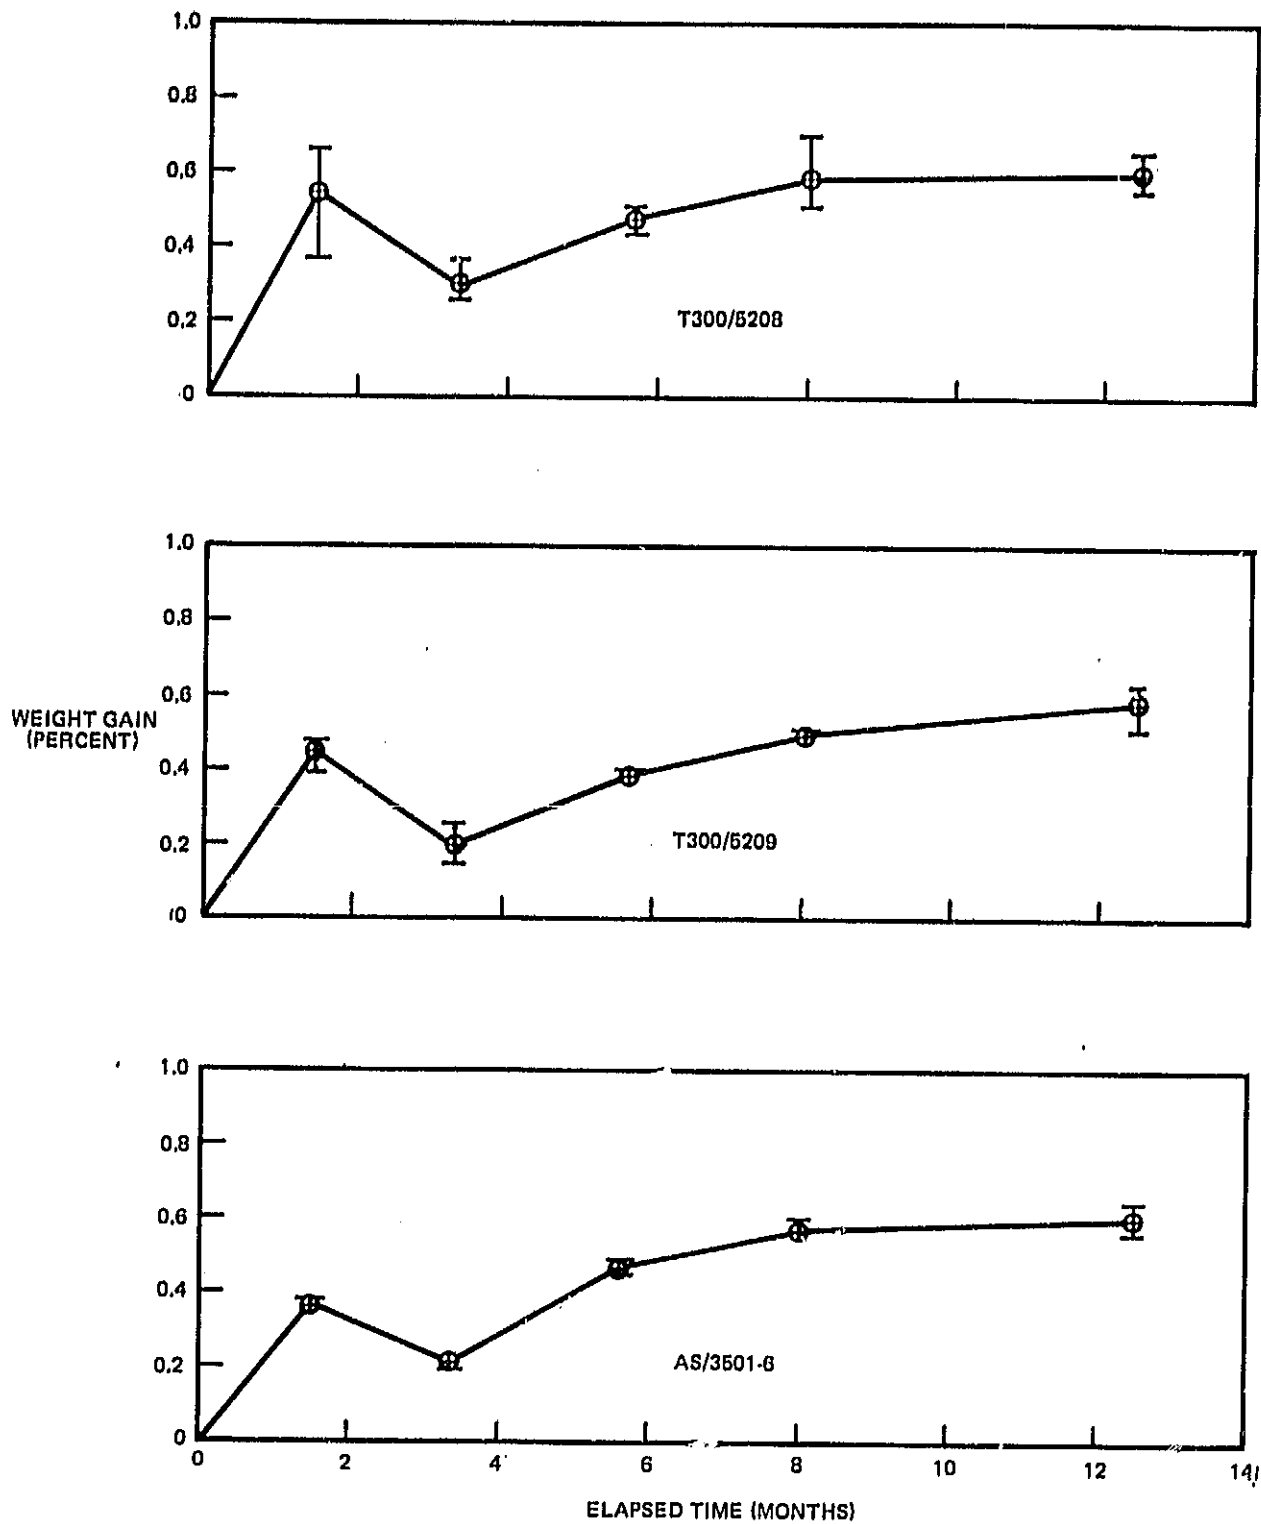
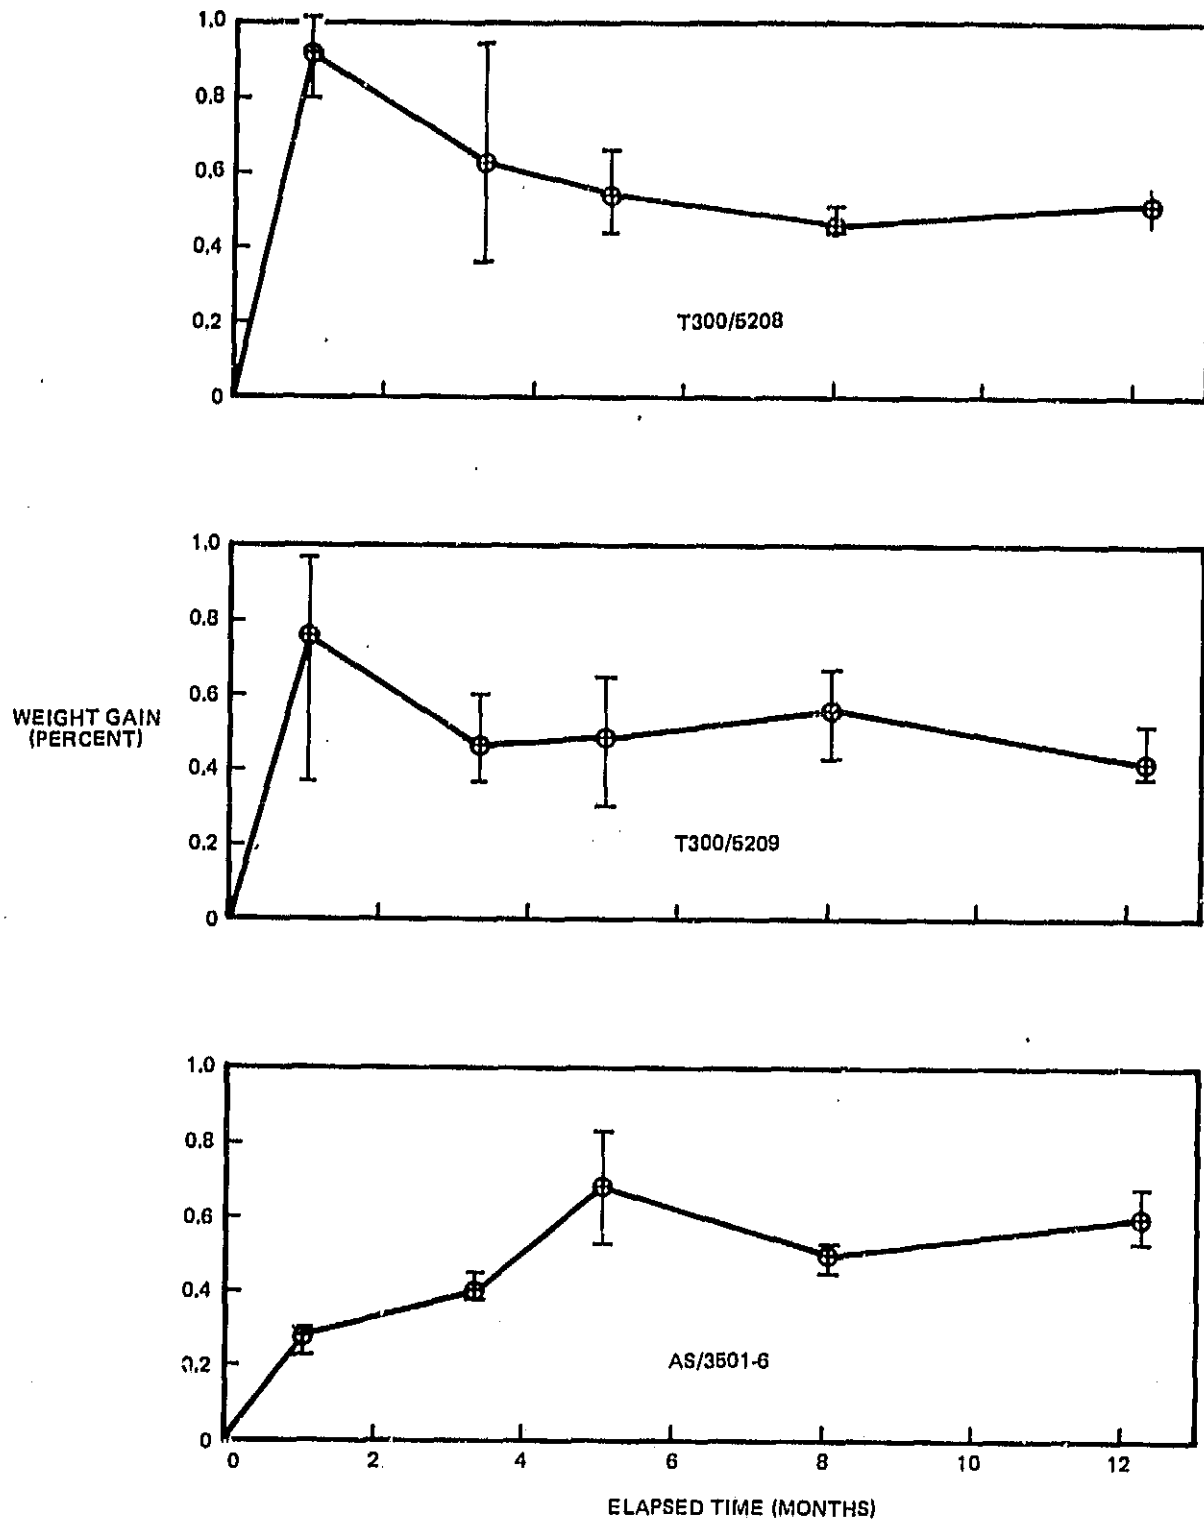
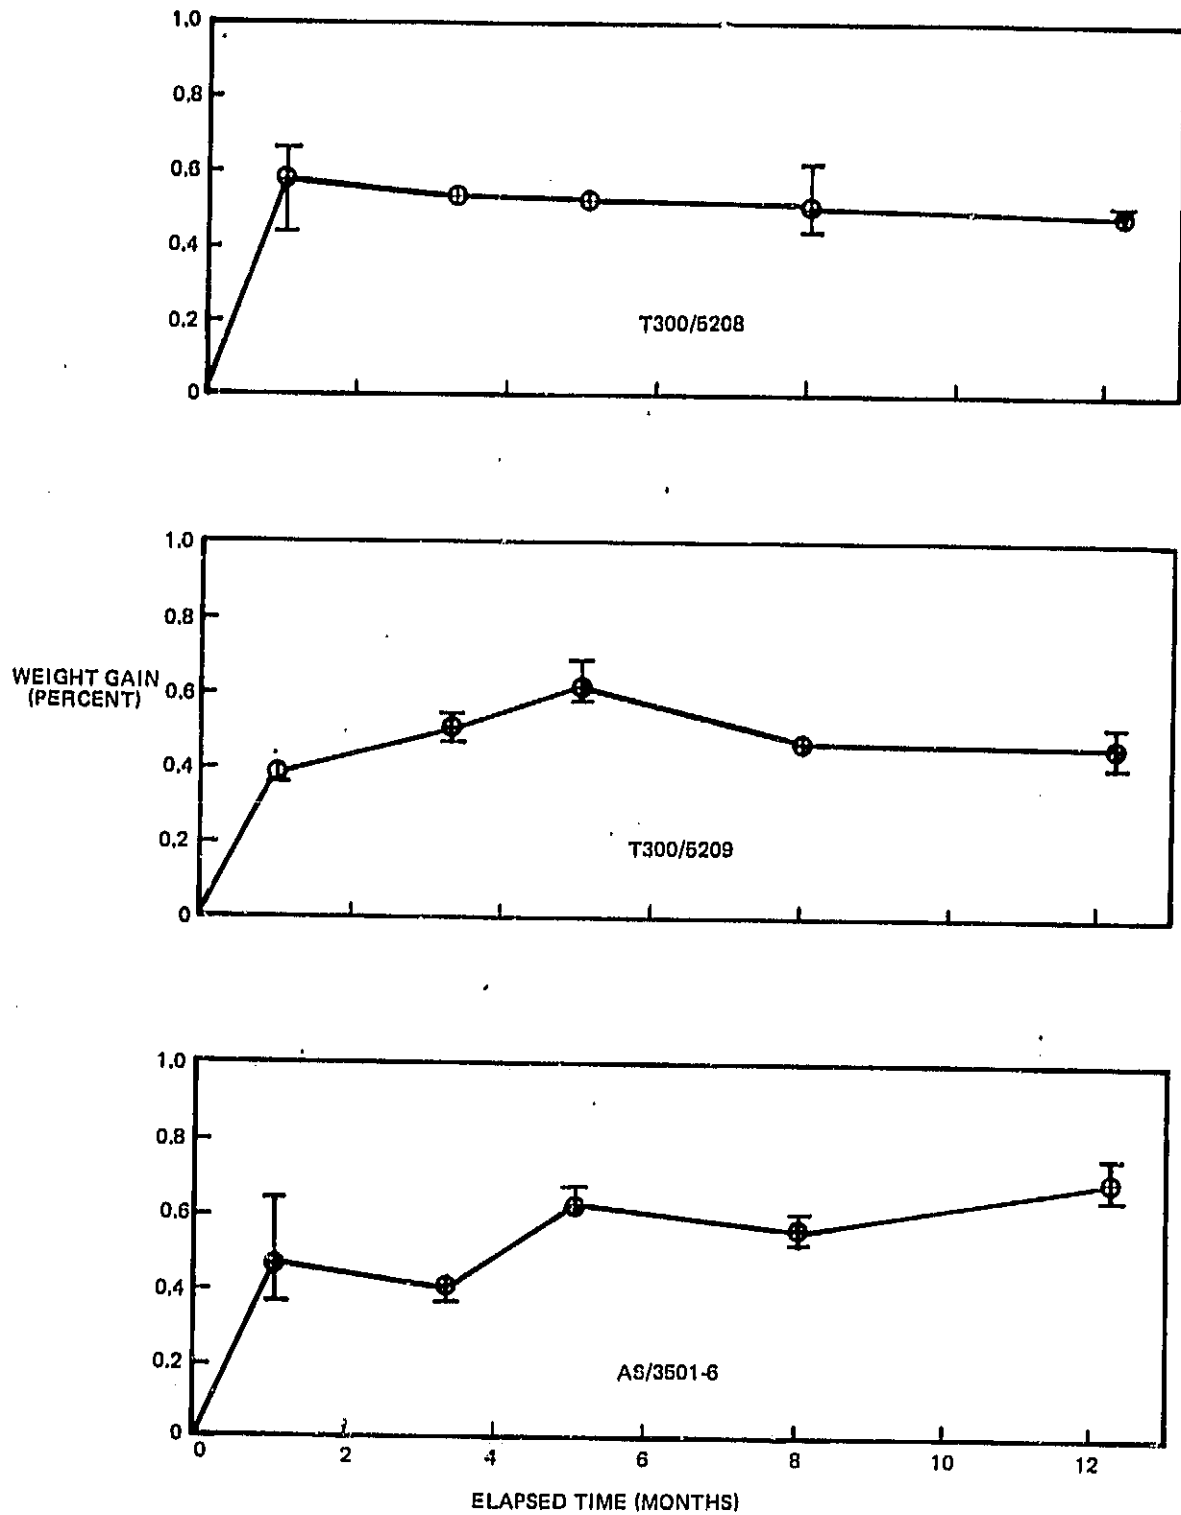
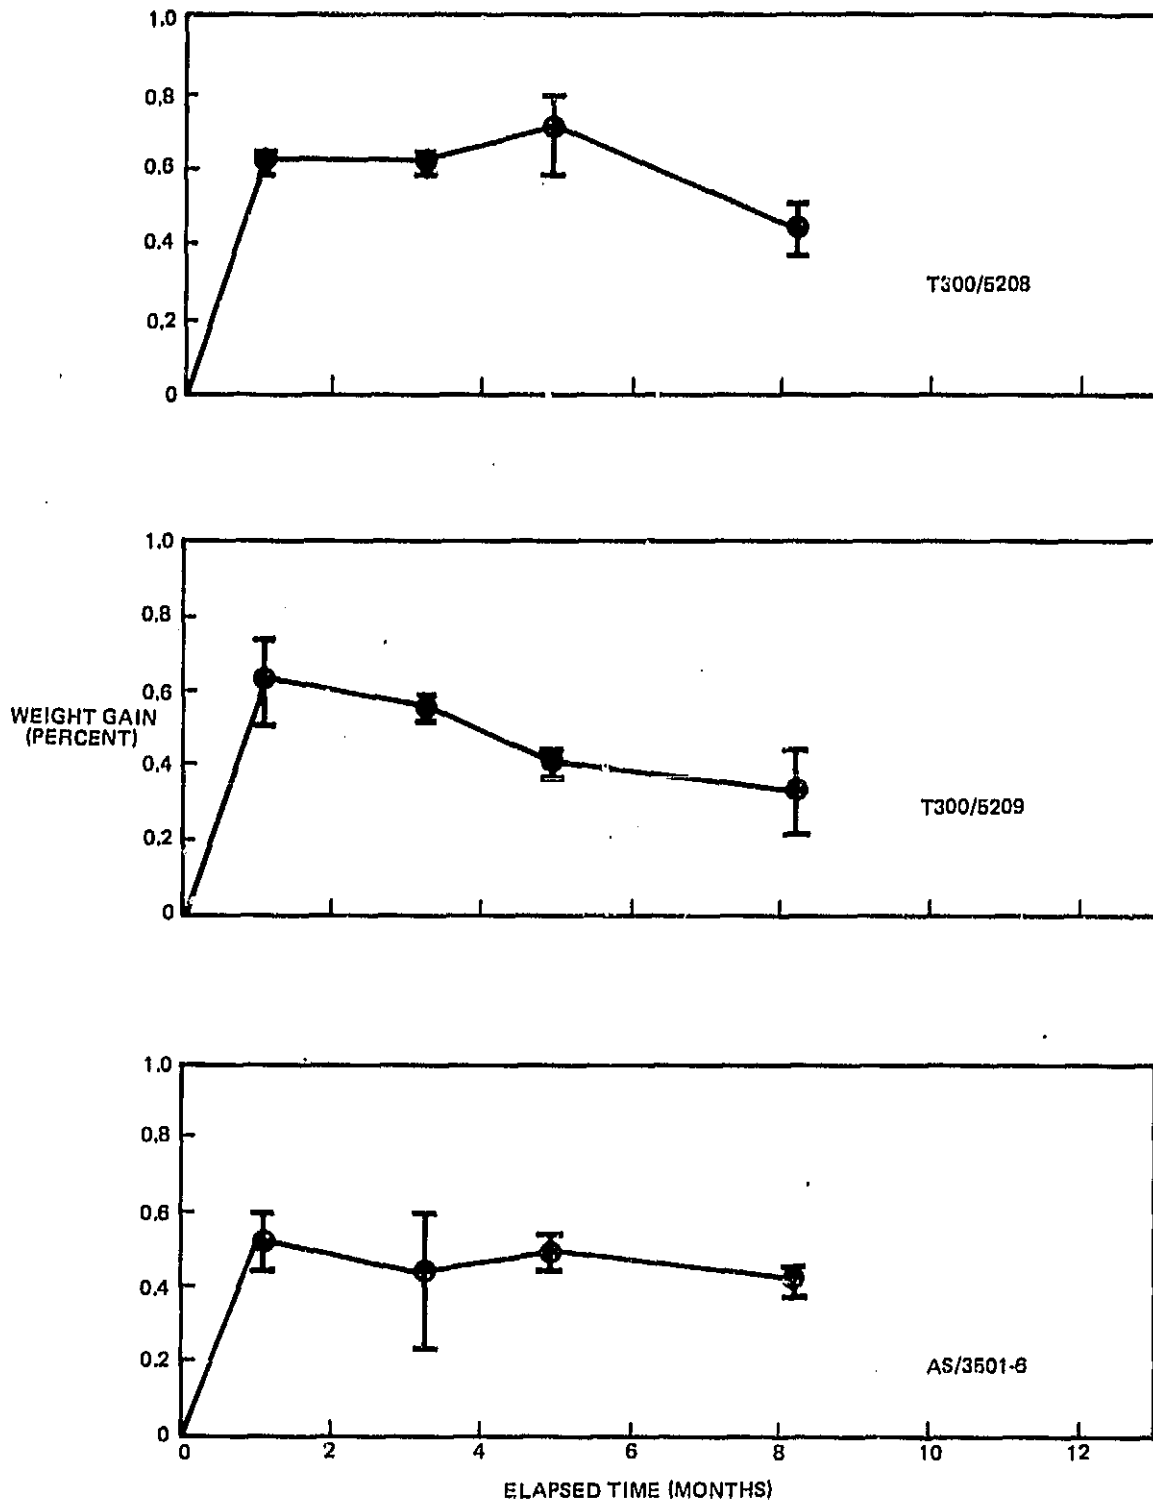
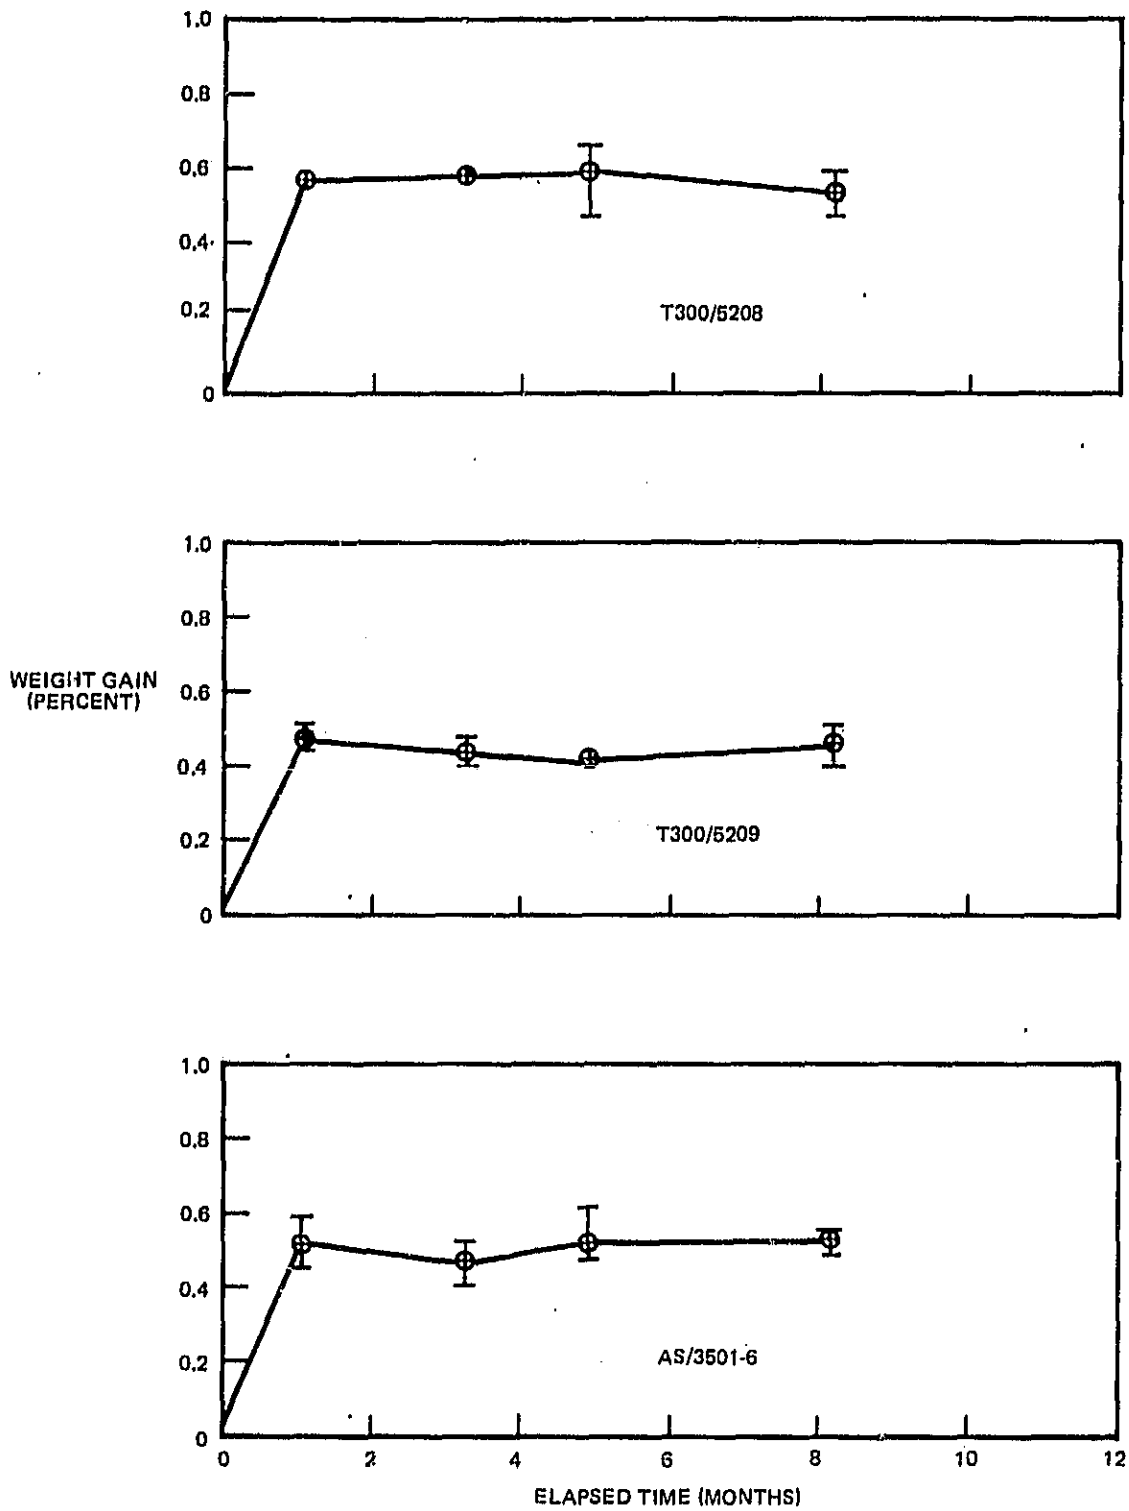
The specimen physical properties and moisture absorption data to date are summarized in Tables 5 through 8. The moisture absorption trends for the various specimen sets are shown graphically in Figures 3 through 10. After about one year of exposure, the average weight gains range from 0.34 to 0.69 percent depending on material system and aircraft installation.
